Assessment of Dam Safety Coal Combustion Surface Impoundments (Task 3) Final Report

American Electric Power

Conesville
Generating Station

February 15, 2010

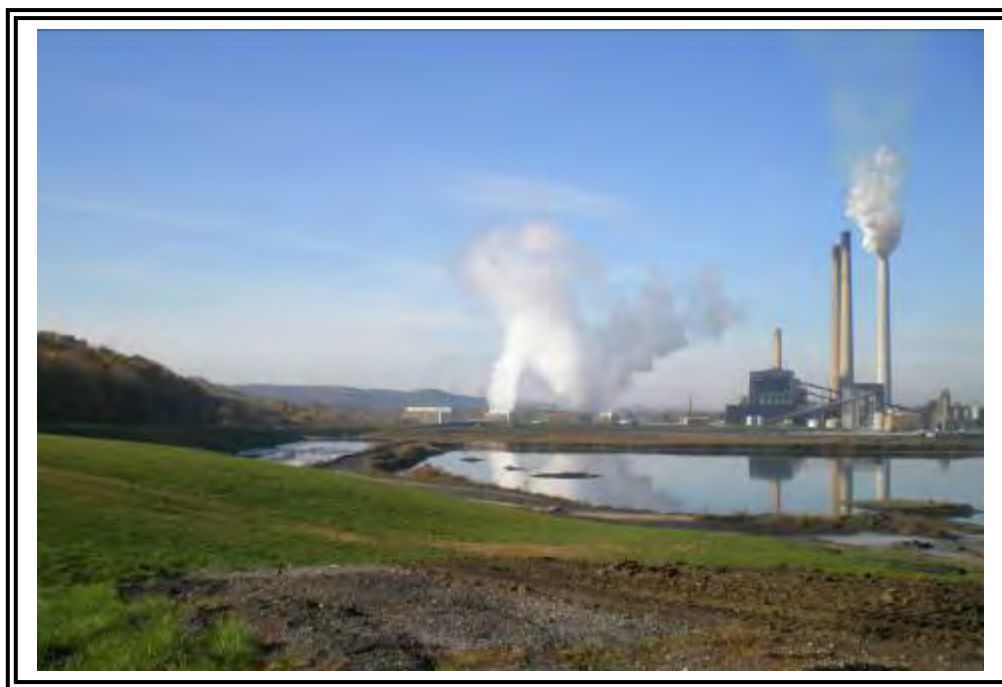
2

Looking southwest across the Ash Pond Complex.

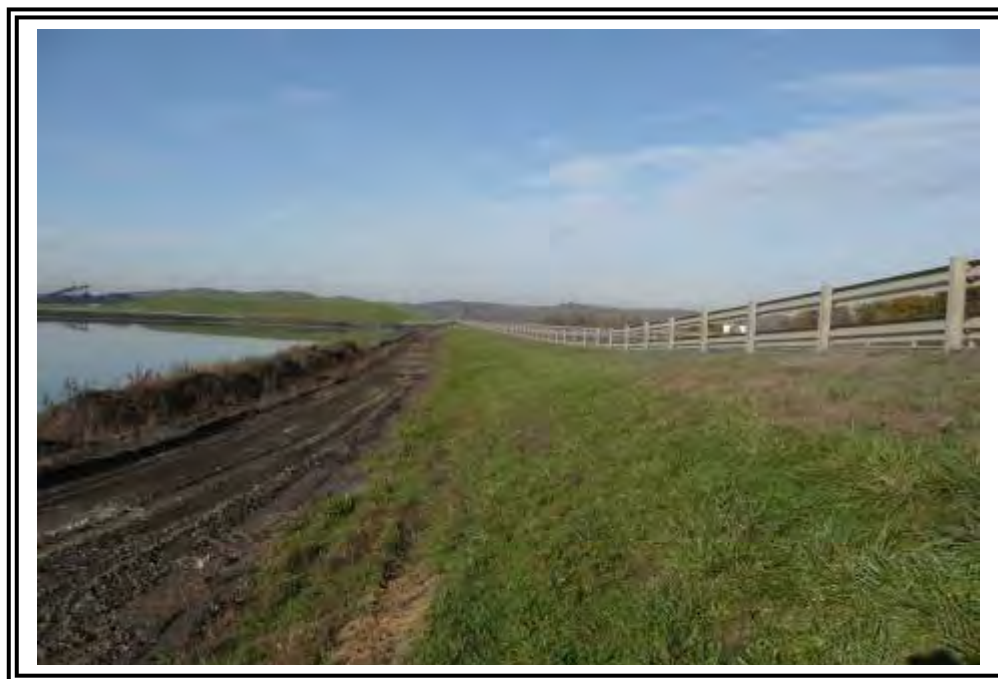
6

Looking west along the upstream slope of the North Haul Road Dike.

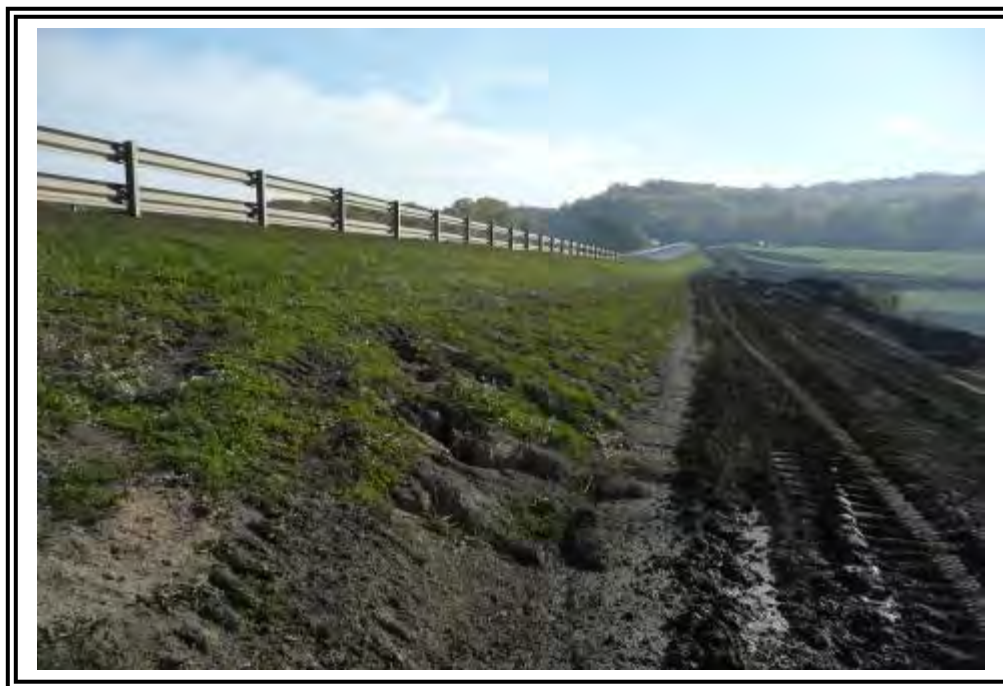
7

Looking east along upstream side of the North Haul Road Dike.

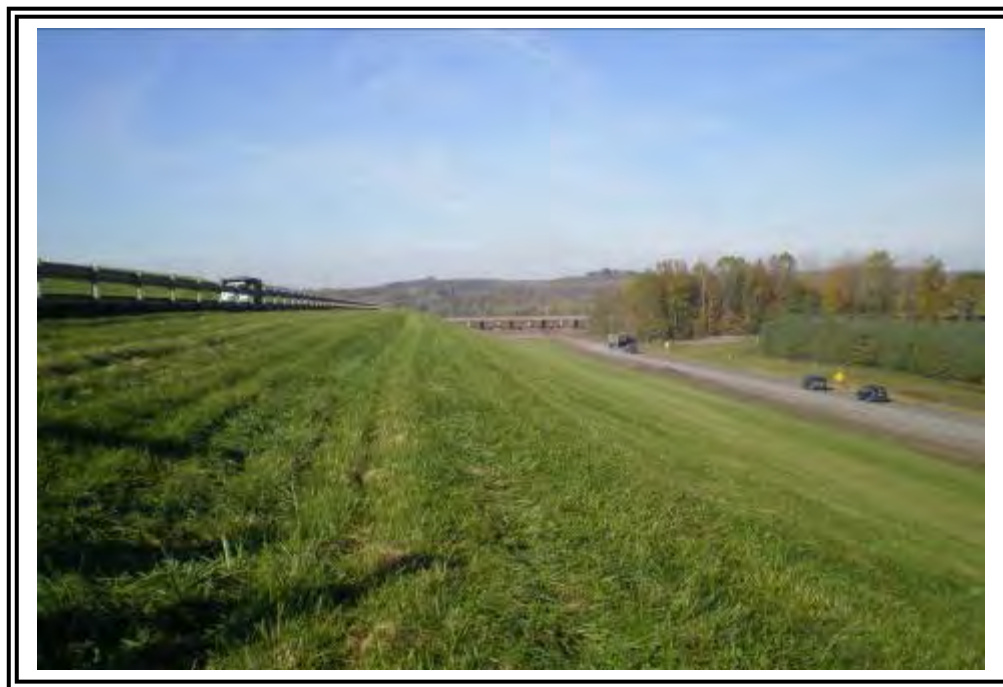
The downstream slope was generally uniformly graded, and covered with appropriate grass vegetation (Photo Nos. 8 and 9). There were isolated rodent burrows as shown in Photo No. 10. There are occasional areas where the grass is sparse, and rutting has occurred from mowing operations as shown in Photo No. 11. The drainage ditch at the toe of the dike, between the dike and County Road 273, has standing water as shown in Photo No. 12. Photo No. 13 shows the drainage pipe which conveys water from the ditch to the opposite side of County Road 273. The water level in the drainage ditch appeared to be controlled by the wetland area on the far side of County Road 273. Recently mowed cattail growth was also observed along the drainage swale area between the dike toe and County Road 273 as shown in Photo No. 49.

Looking west along downstream slope of the North Haul Road Dike. Country Route 273 shown on the right.

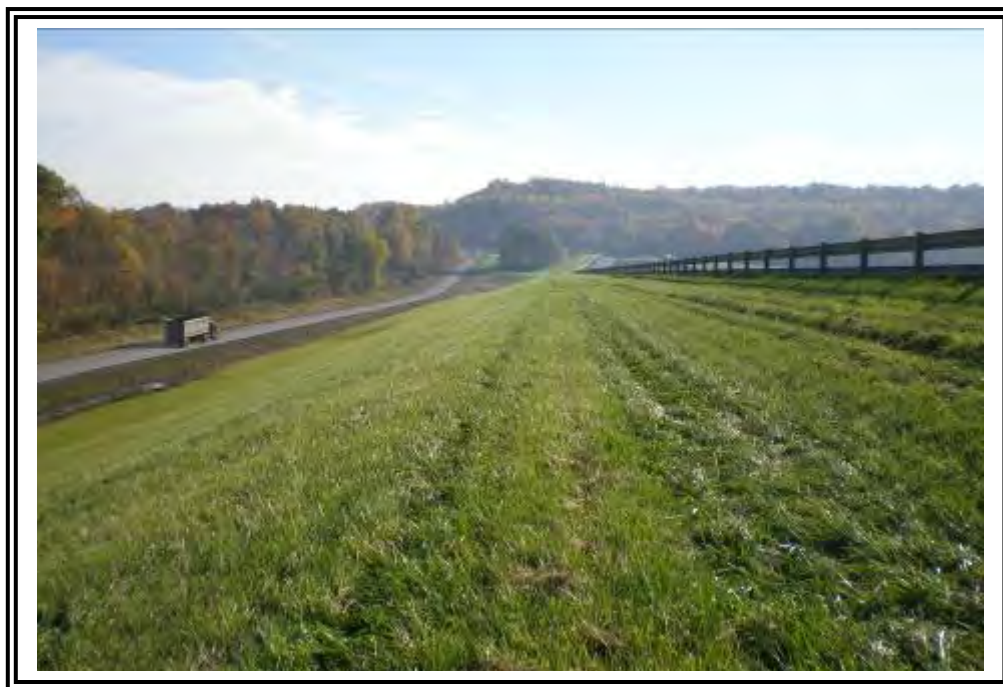
The Northern Haul Road Dike along the northern side of the complex is about 1,880 feet long and about 35 feet high. A typical cross section through the Northern Dike is shown in Figure 4. In general, the alignment of the dike crest does not show signs of change in its horizontal alignment. No evidence of prior releases, failures or patchwork was observed at the time of the site visit. Photo Nos. 1 and 9 show the dike crest alignment.

Looking east along downstream slope of the North Haul Road Dike.

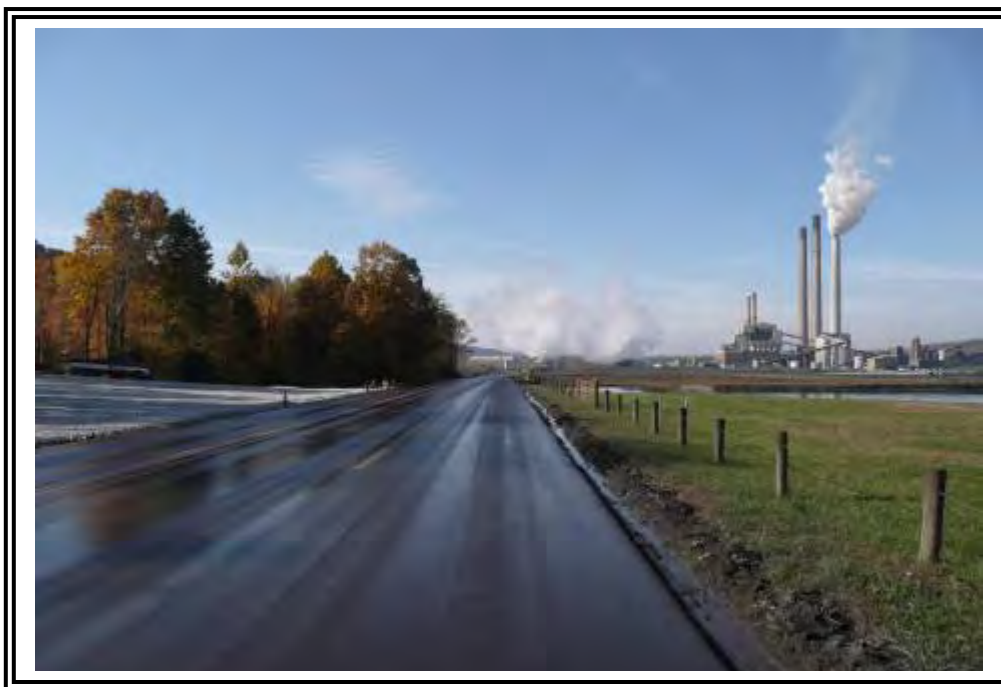
In general, the alignment of the Coal Haul Road and Secondary Dike crests do not show signs of change in horizontal alignment. No evidence of prior releases, failures or patchwork was observed at the time of the site visit. Photo Nos. 15 and 16 show the general condition of the dike crest.

Looking southwest along the Coal Haul Road. Road is wet to keep the dust from trucks down.

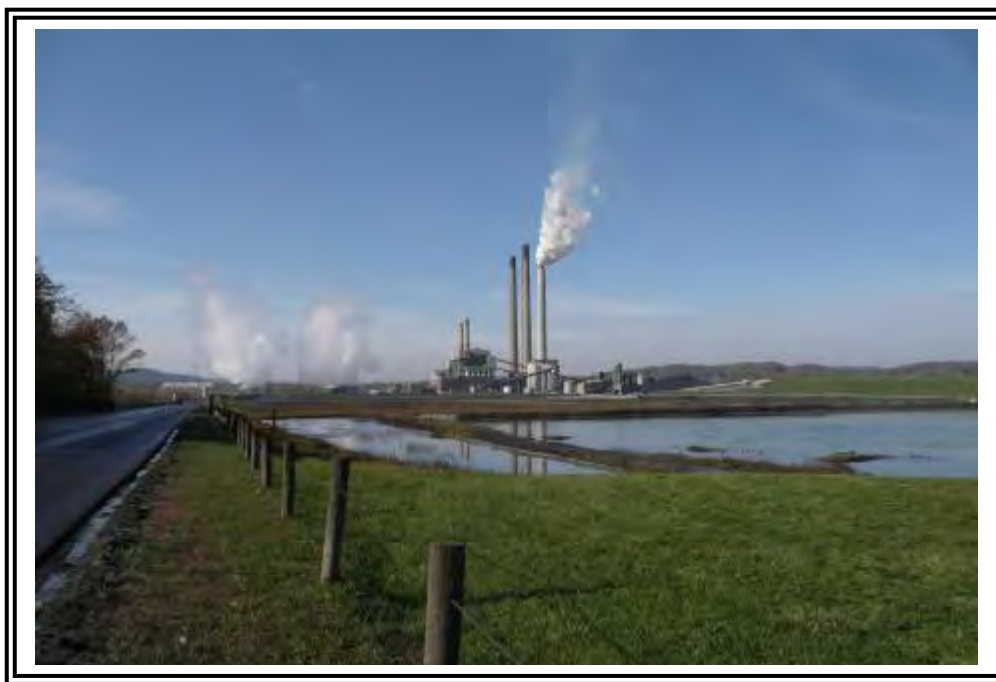
The upstream slope along the Fly Ash Pond created by the Coal Haul Road and Secondary Dikes was relatively uniform and covered with appropriate grass cover. Photo Nos. 16 through 18 shows the general condition of the upstream slope in this area. The crest and upstream slope of the Secondary Dike adjacent to the Clearwater Pond is reasonably uniform as shown in Photo No. 19.

Looking southwest along the northeast crest and upstream slope of the Coal Haul Road Dike.

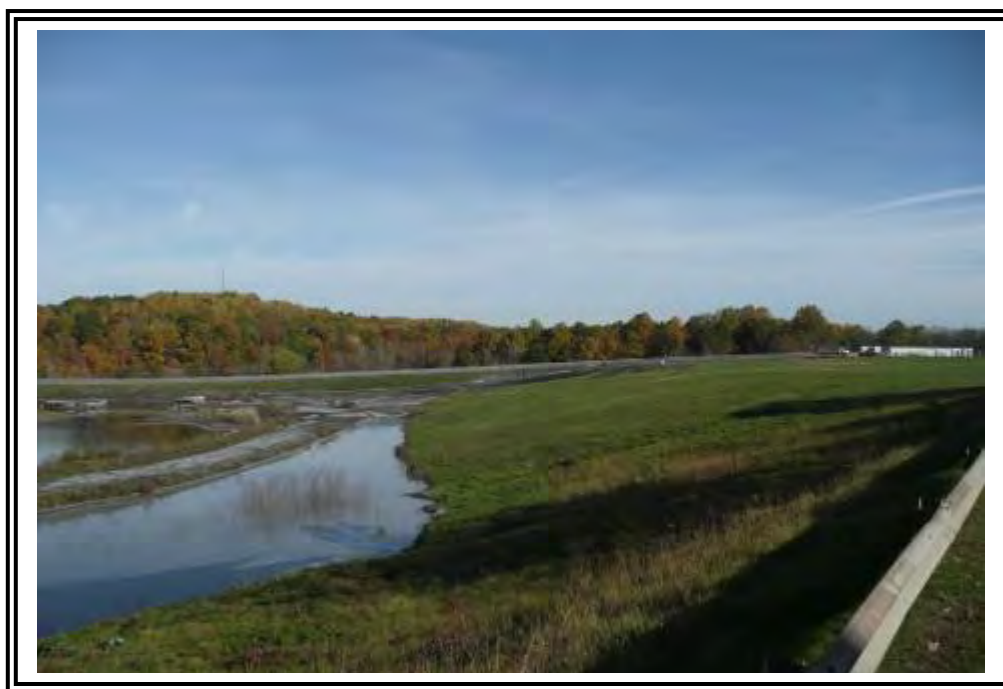
17

Looking northeast along upstream slope of the Coal Haul Road Dike.

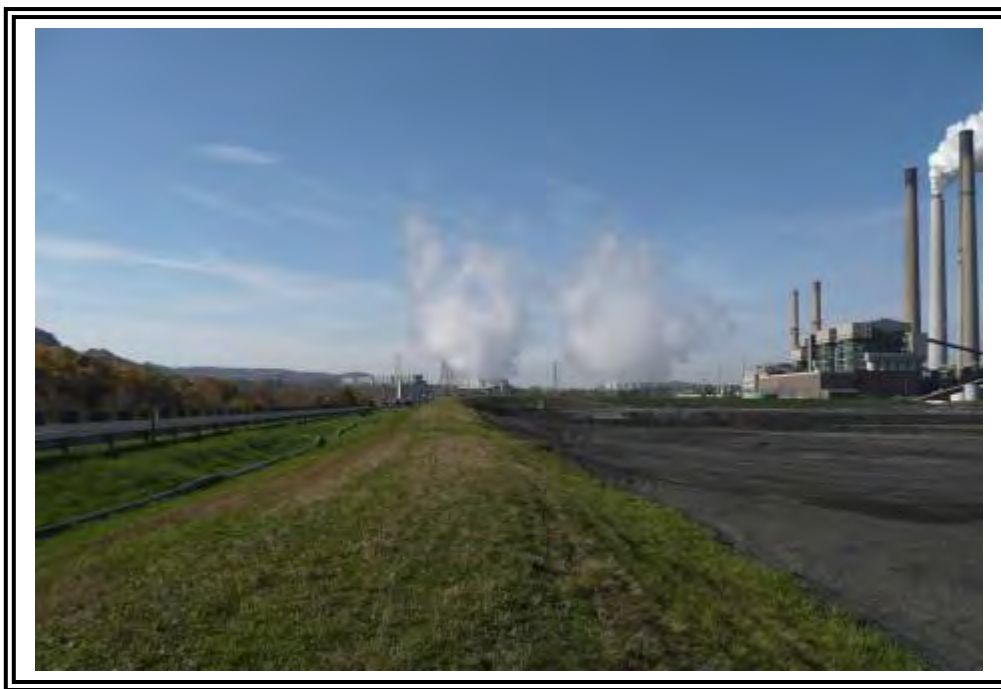
19

Looking southwest along the crest of the Coal Haul Road Dike where its alignment leaves the haul road and runs parallel to it.

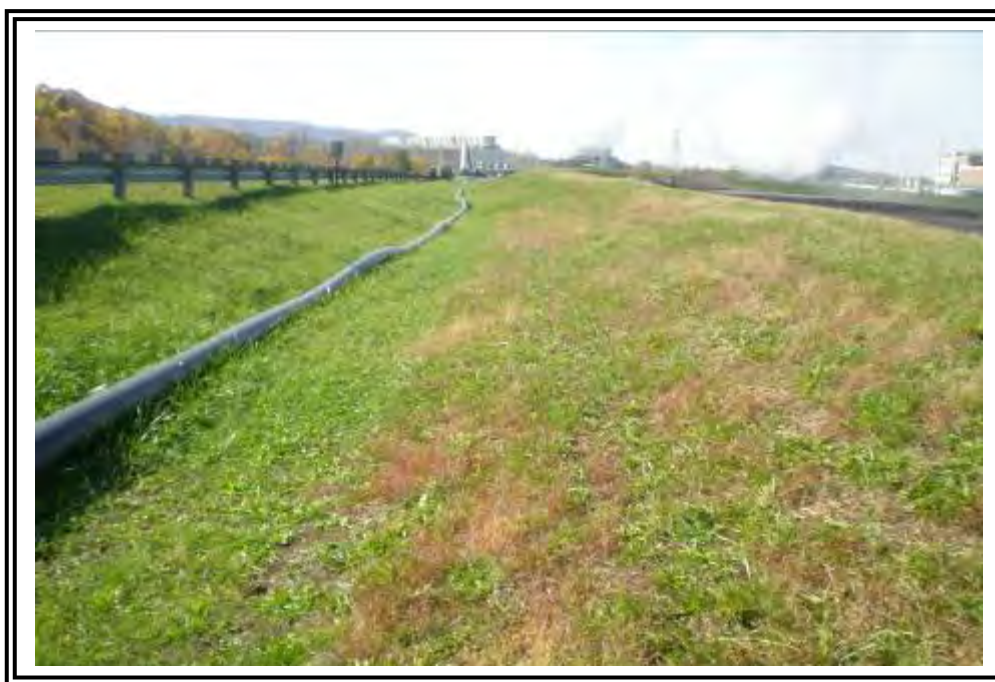
Photo Nos. 24 and 28 shows that the downstream slope of the Secondary Dike adjacent to the Clearwater Pond was uniformly graded with appropriate grass cover. Photo No. 27 shows the upstream slope of the Secondary Dike adjacent to the Clearwater Pond. Isolated rutting and loss of the grass cover from mowing operations, as seen in Photo No. 29, was observed during the inspection.

Looking southwest along downstream slope of the dike where the dike runs parallel to the west of the coal haul road.

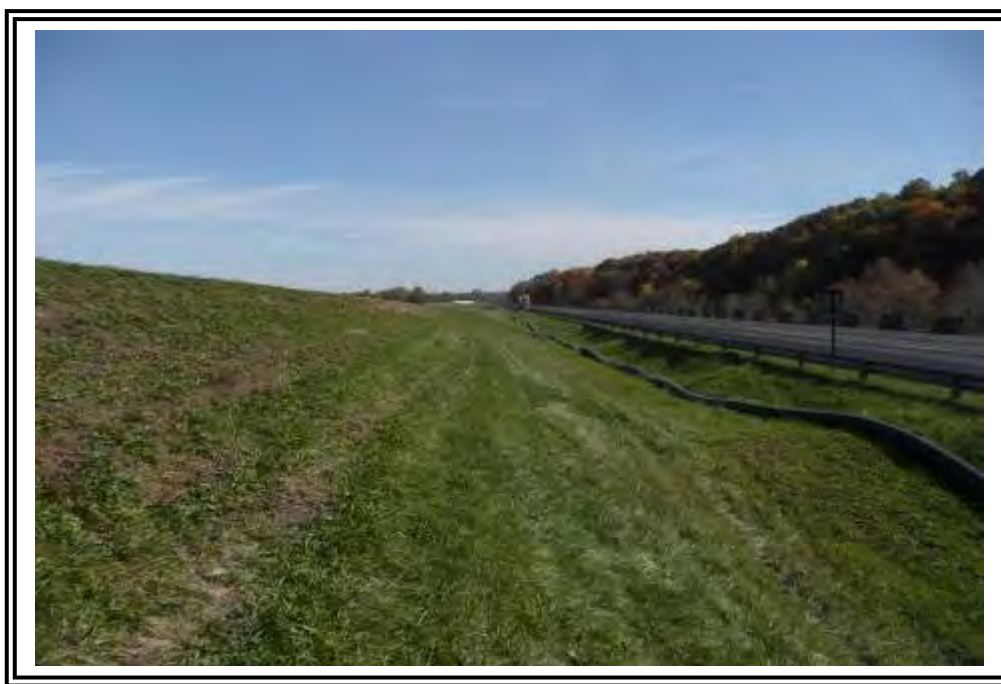
28

Looking northeast along the downstream slope of the Coal Haul Road Dike adjacent to the Clearwater Pond.

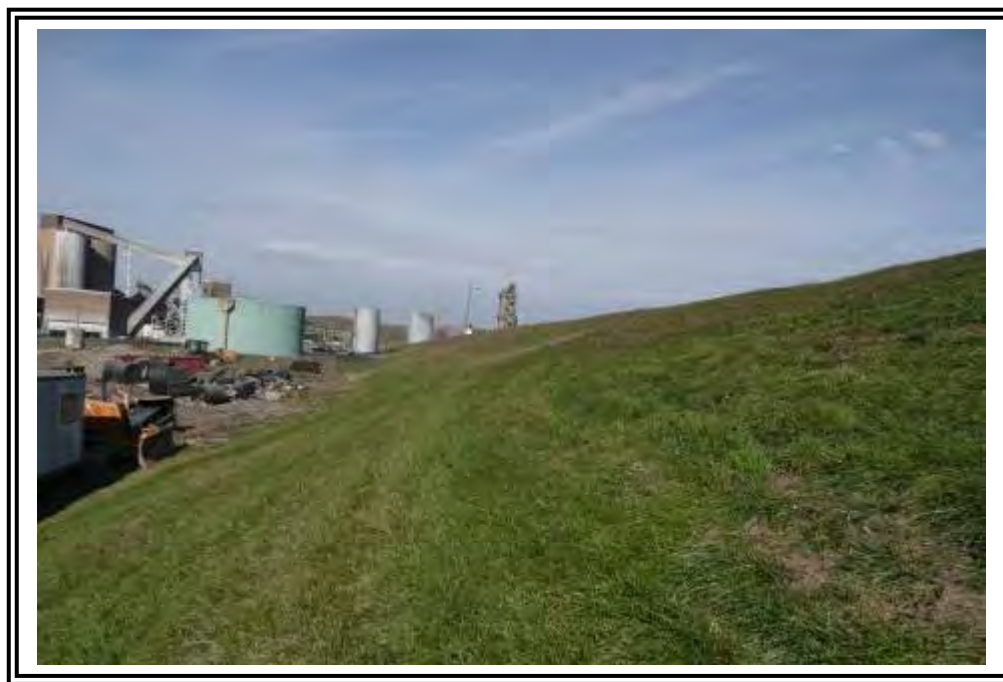
30

Looking northwest along downstream slope of the Southwest Dike.
The green metal cleaning tank can be seen on the left side of the background in the photo.

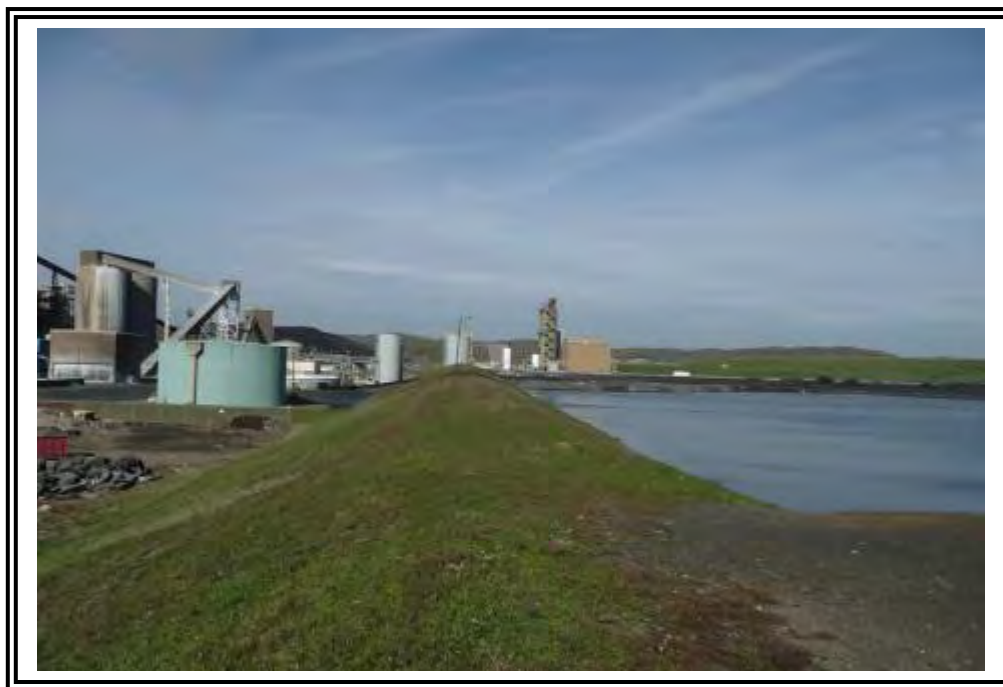
aerial survey, this would leave about 3 to 5 feet of effective freeboard above the water level at the edge of the bottom ash delta surface. Photo Nos. 39 and 59 show this ramp excavation through the dike. In general, the alignment of the Southwest Dike crest does not show signs of change in its horizontal alignment. No evidence of prior releases, failures or patchwork was observed at the time of the site visit. Photo No. 31 shows the dike crest alignment.

Looking northwest along crest of the Southwest Dike.

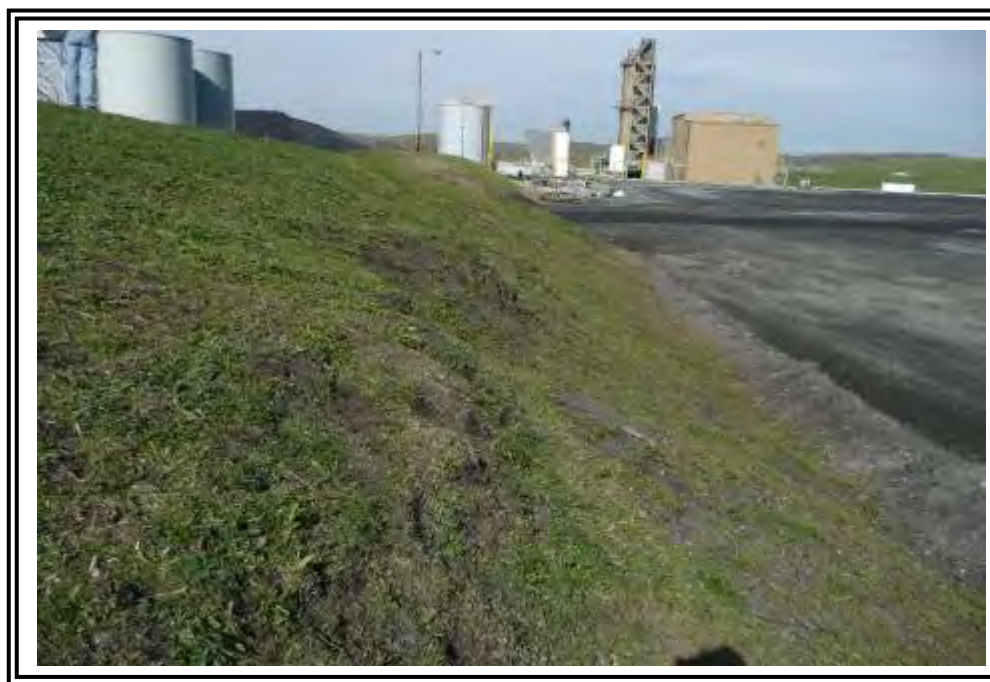
38

Looking northwest along upstream slope of the Southwest Dike near the northwest corner of the Bottom Ash Pond.
Note slope undulations likely resulting from past grading activities.

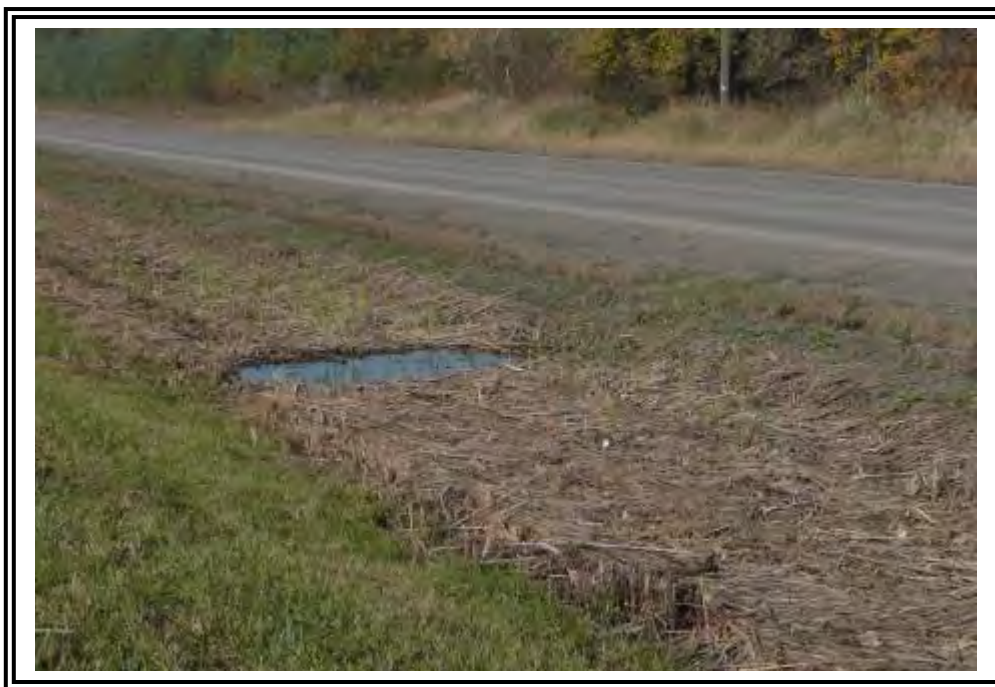
49

Recently mowed cattail growth in drainage swale at toe of the North Haul Road Dike and County Route 273.

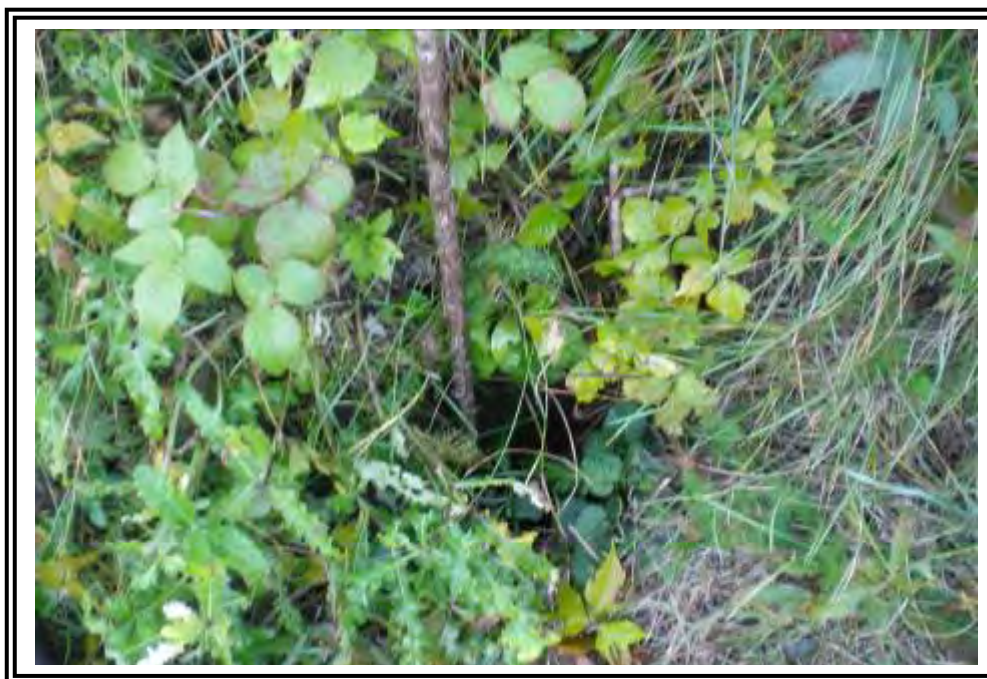
52

Rodent burrow on downstream slope of Coal Haul Road Dike.

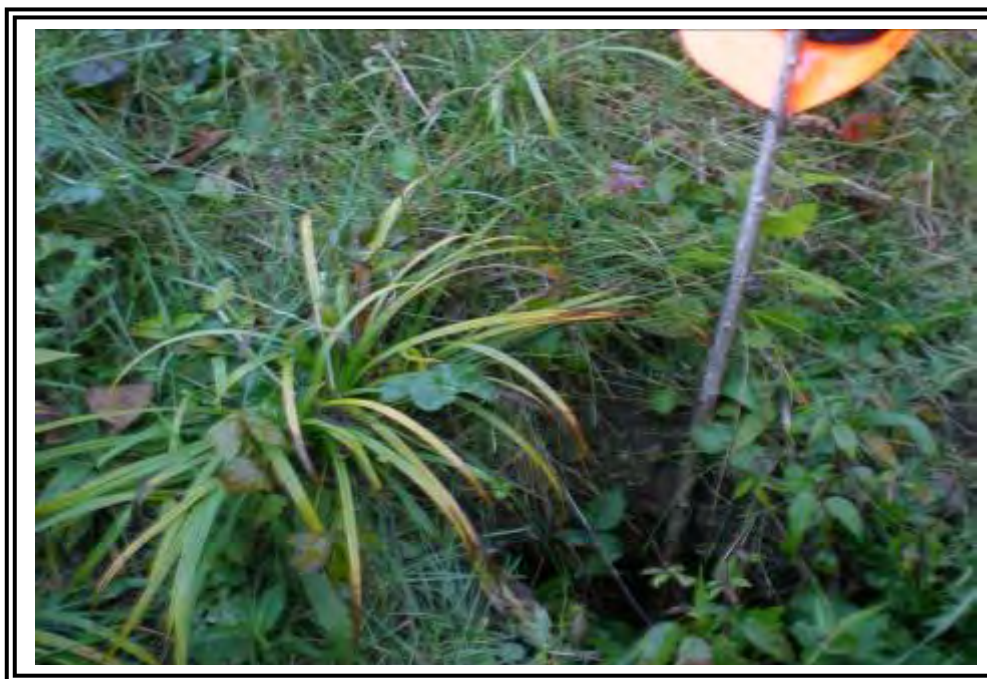
54

Another rodent burrow on downstream slope of Coal Haul Road Dike.

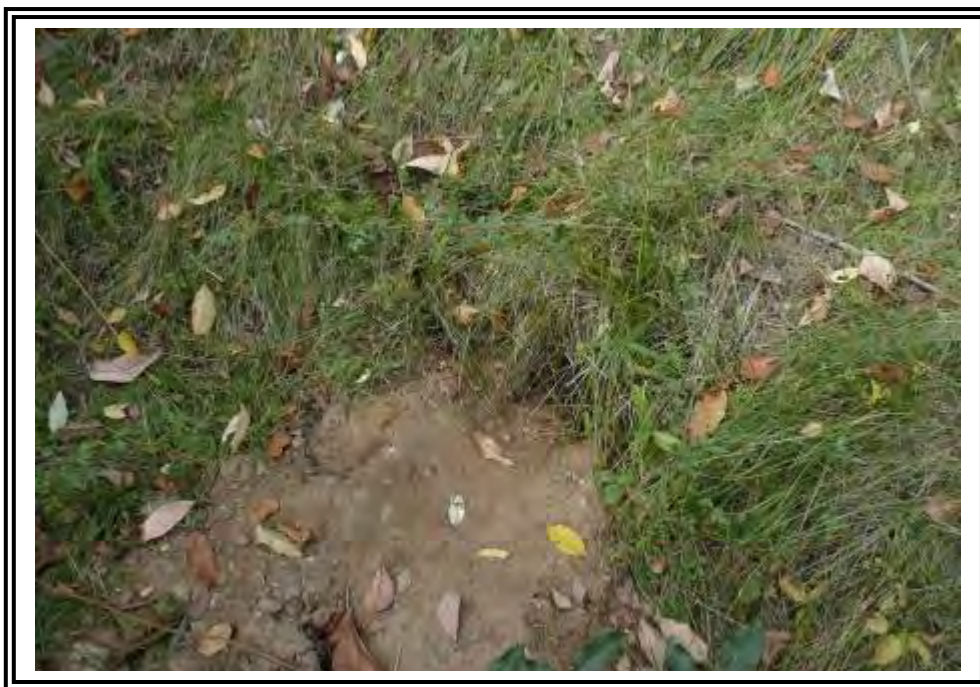
55

More recent rodent burrow in Coal Haul Road Dike with exposed soil spoil.

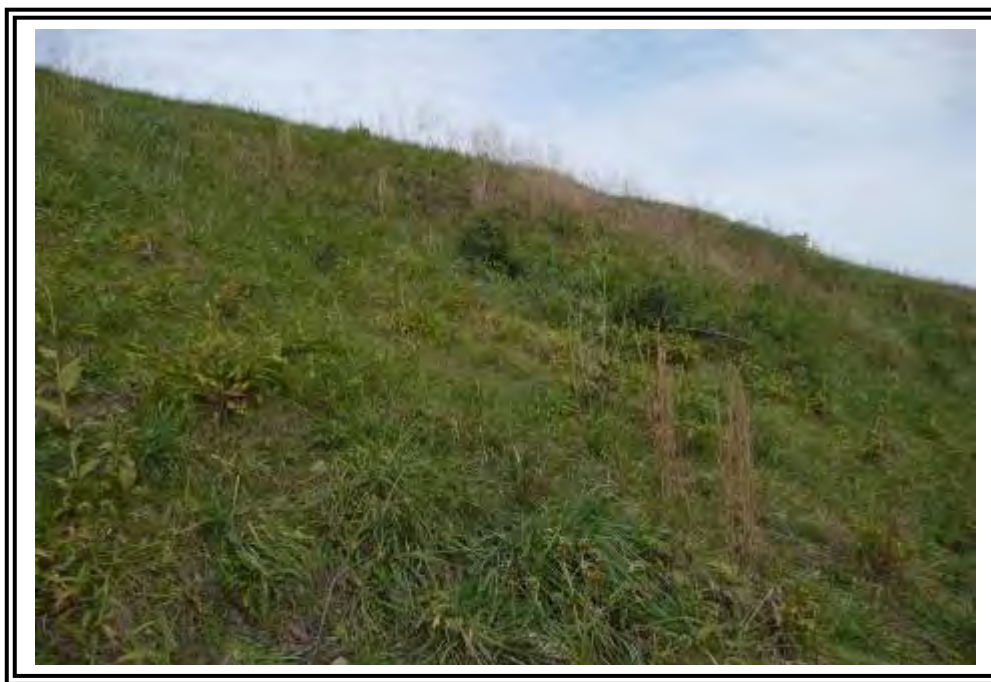
56

In addition to the erosion features, a scarp with an adjacent depression and slump was also observed on the downstream slope along with older grass covered deformation features. These are likely the result of surficial soil softening, concentrated runoff from the roadway, and dust control efforts. In the case of the latter, finer grained coal dust, soil, and other debris is washed or swept from the road onto the slope and build up over time. These are shown in Photo Nos. 47, 48, and 56. Examples of the soil and dust transport from the roadway with subsequent grass cover loss can be seen in Photo Nos. 57 and 58.

Grass covered deformation on downstream slope of Coal Haul Road Dike.

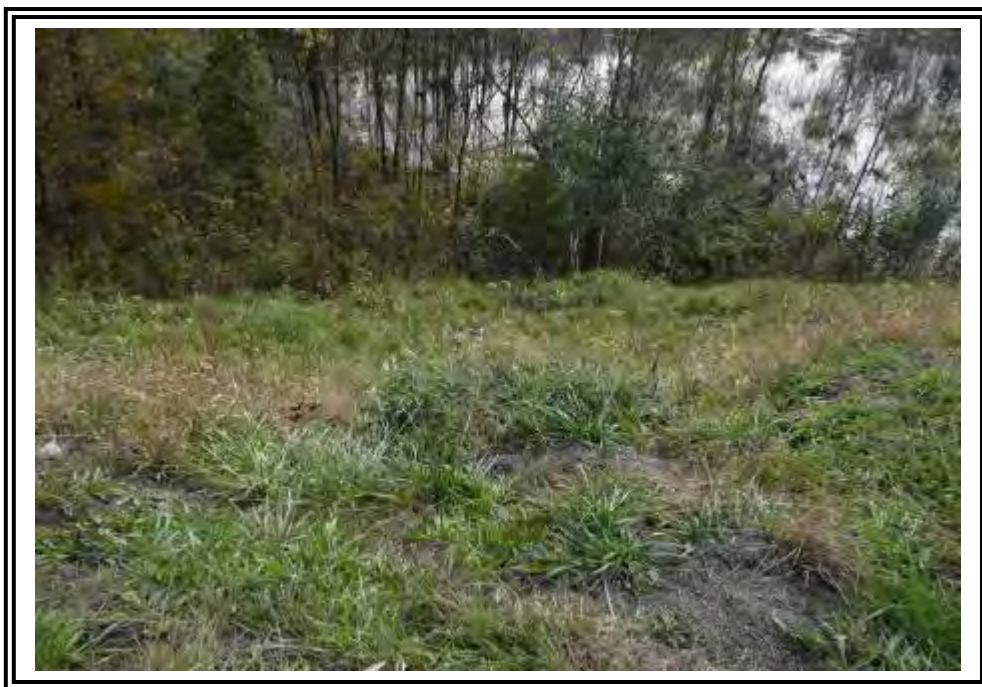
57

Example of soil and coal dust transport and intermittent grass cover loss near crest of Coal Haul Road Dike.

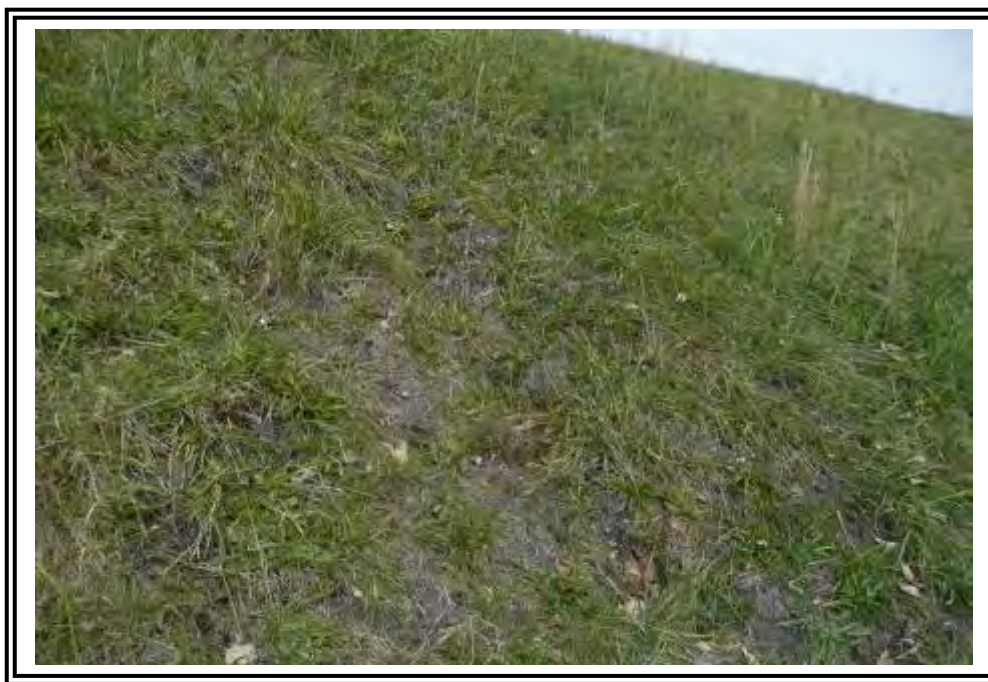
58

Soil and coal dust transport with intermittent grass cover loss on downstream slope of Coal Haul Road Dike.

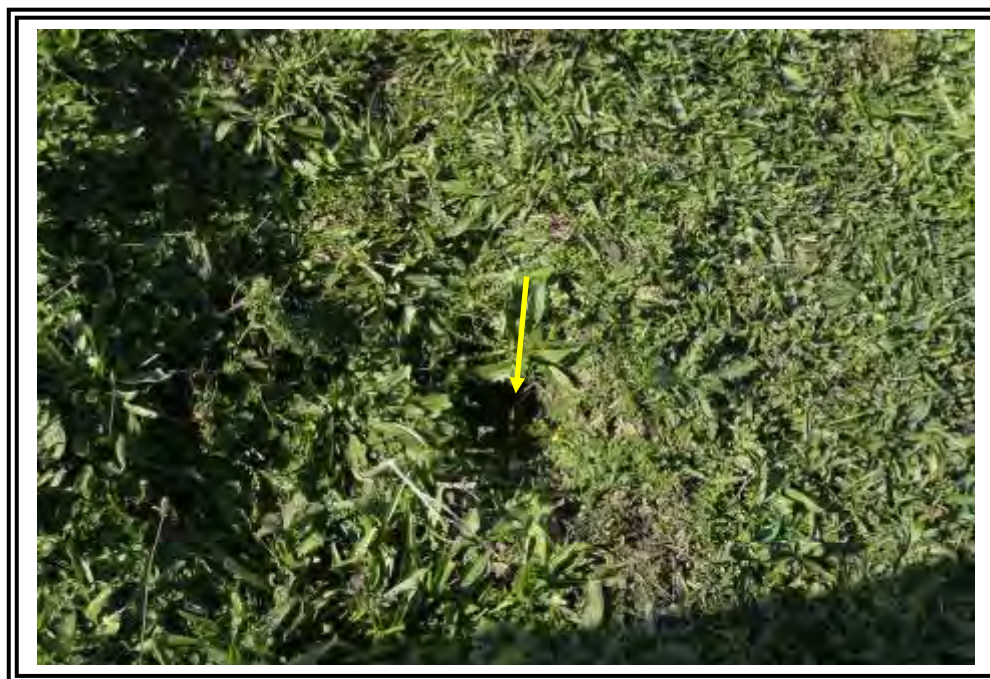
60

Collapsed, vegetated rodent burrow on upstream slope of Southwest Dike, likely abandoned (See arrow).

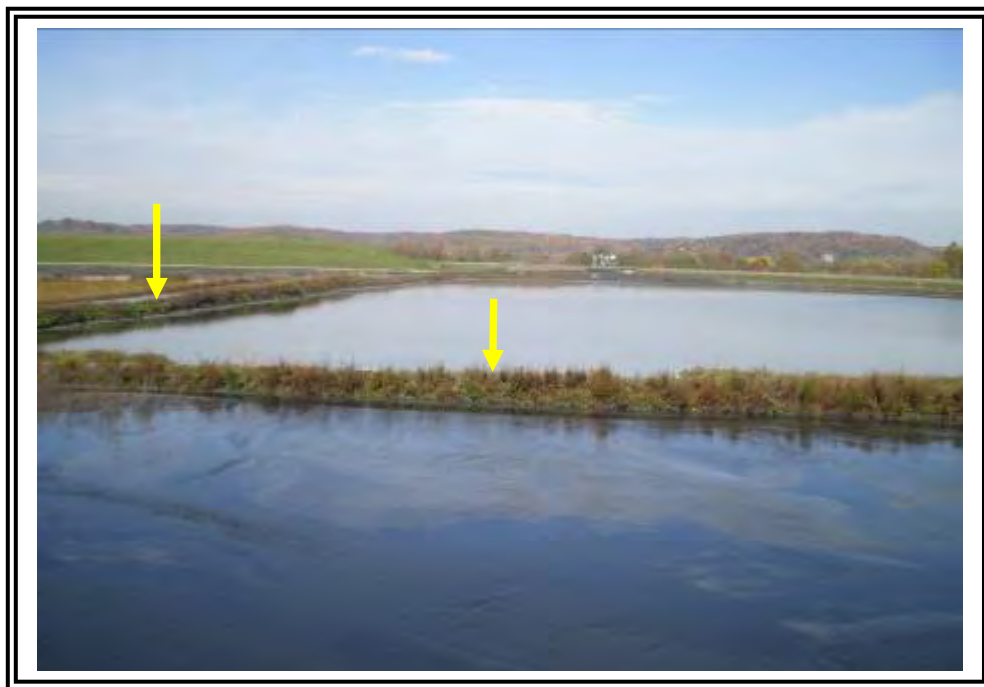
62

Closer view of interior divider dikes (see arrows) the Fly Ash Storage Area and Central Fly Ash Pond area.

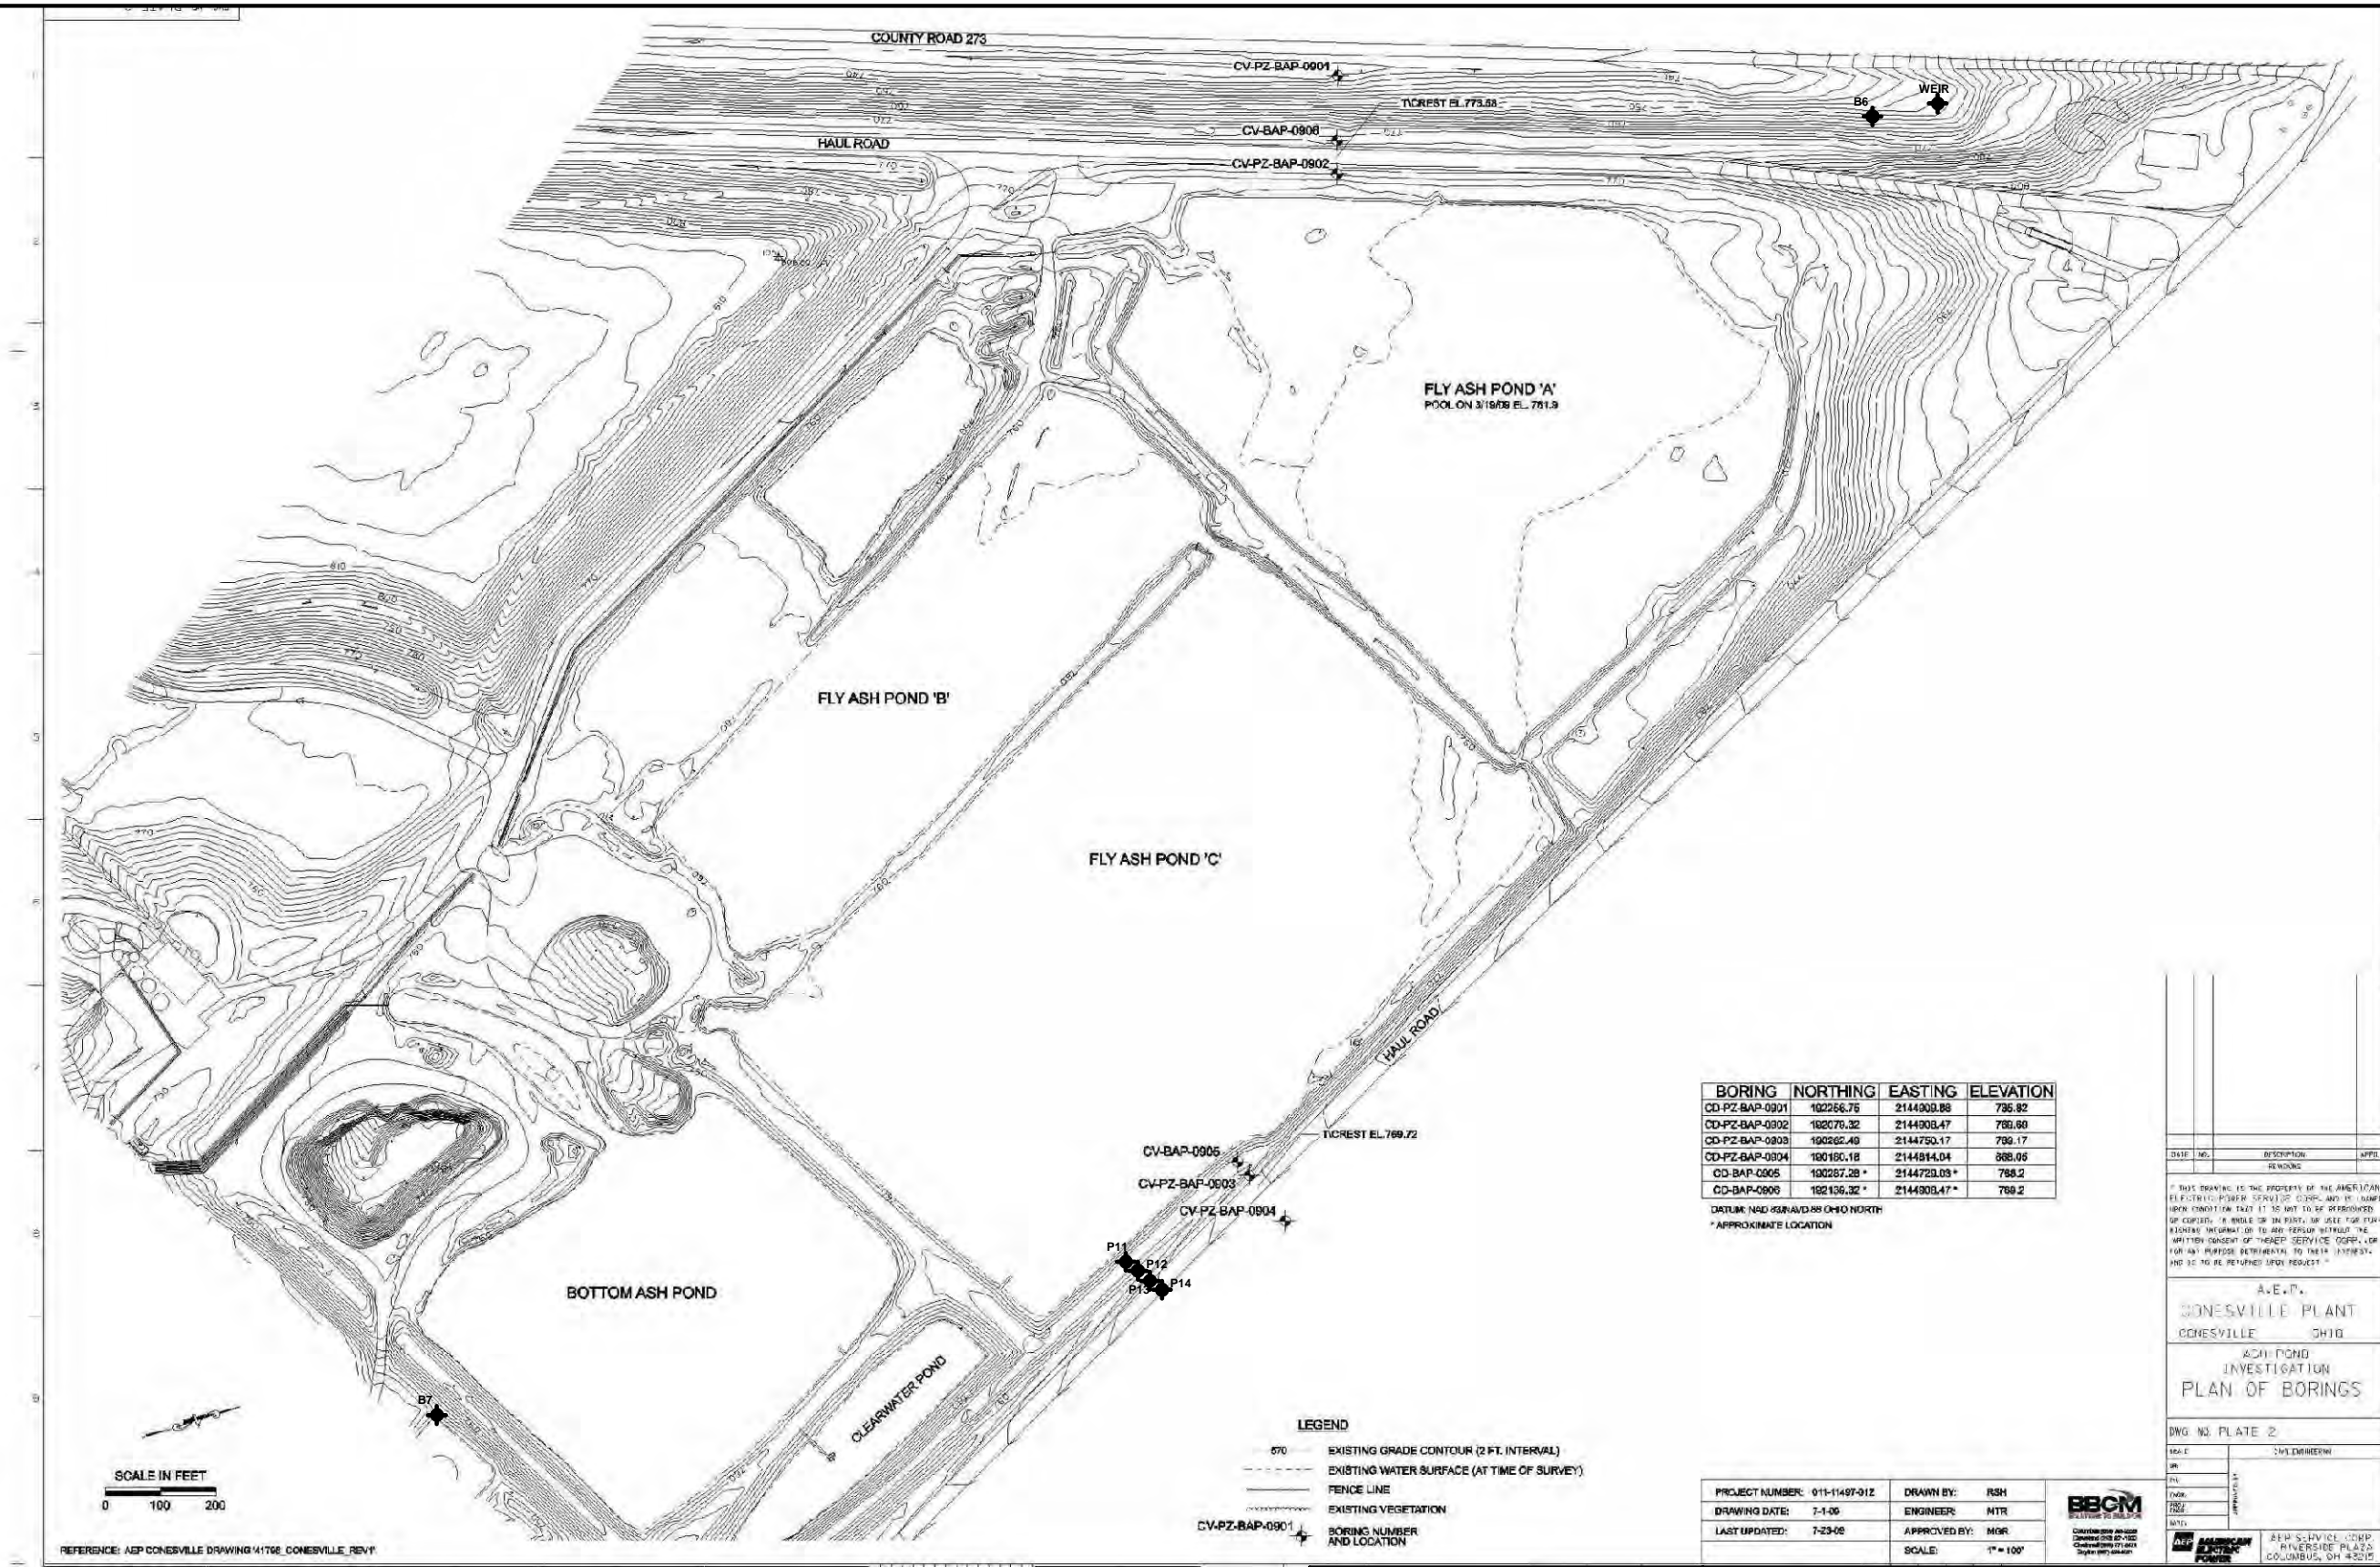
PROJECT NO.
20085.1040
DATE: 02/2010
FIGURE 7

There are 10 piezometers located on the Northern Haul Road Dike, the Coal Haul Road Dike, and on the Southwest Dike at the approximate locations shown on Figure 7. Four of these piezometers were installed as part of the 2009 geotechnical exploration program concerning the stability of the Ash Pond Complex dikes. Additionally, the water level within the ponds is recorded at the outlet structures. A weir is located in the drainage ditch between the Northern Haul Road dike and County Road 273; however, due to weed growth, measurements have not

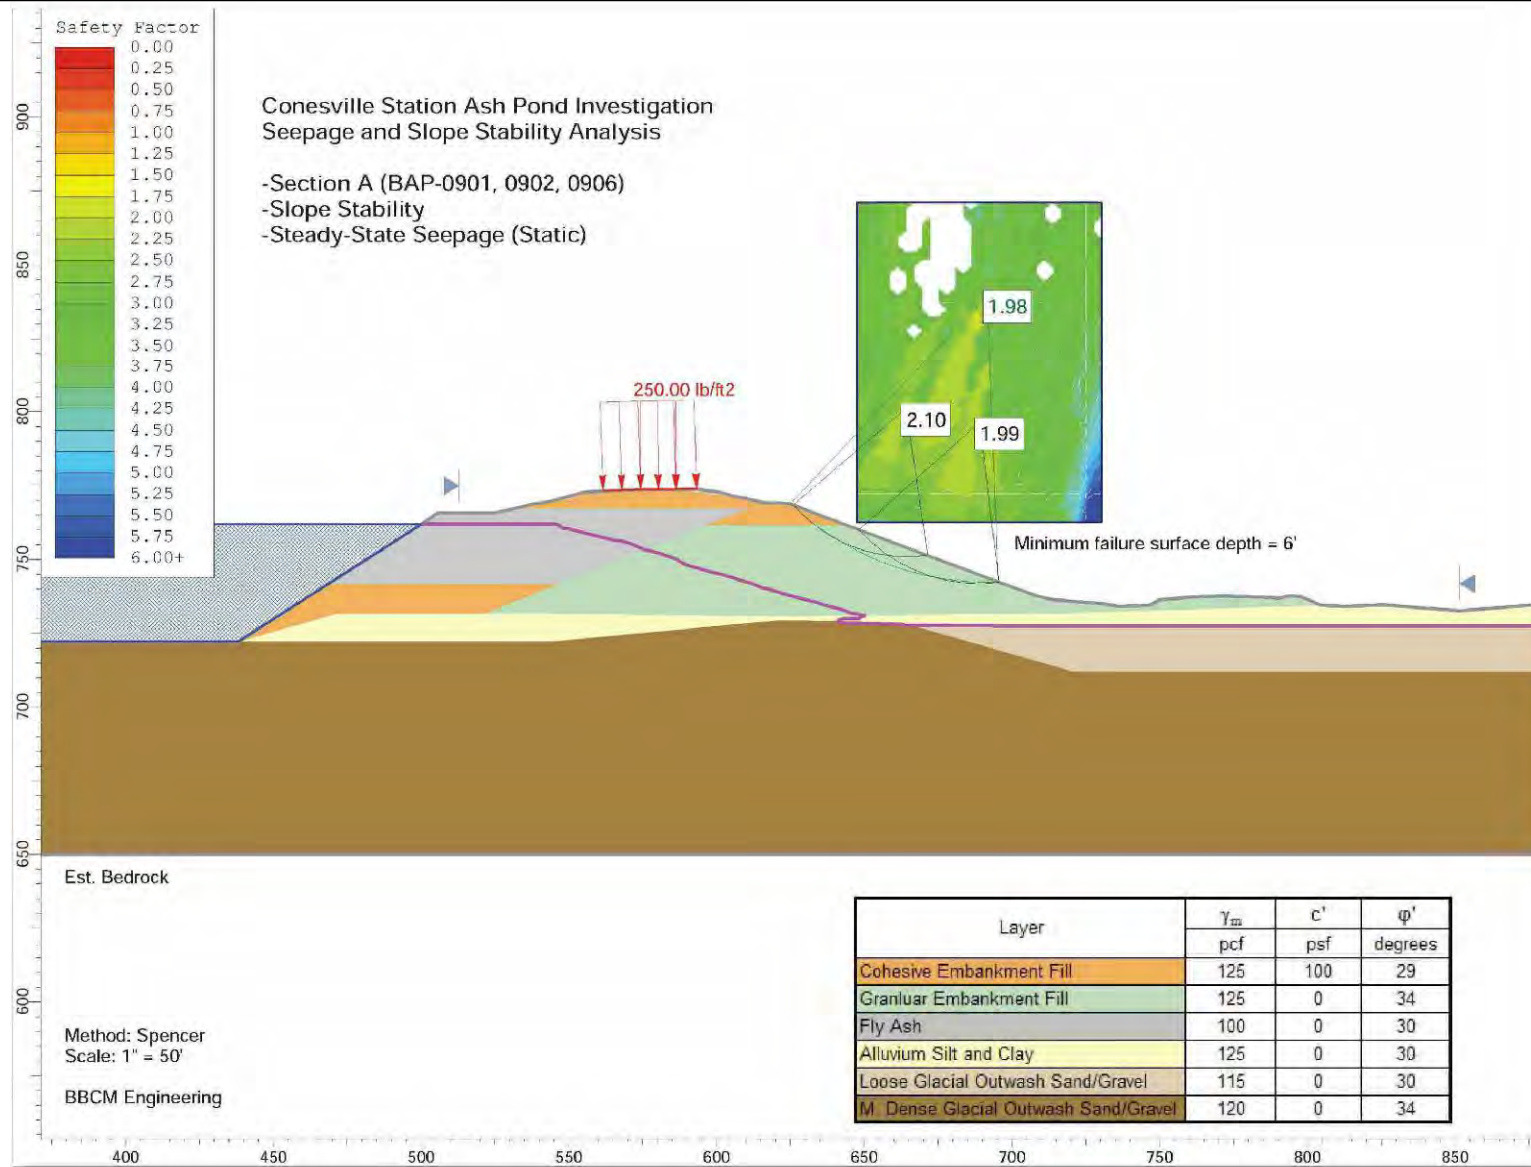
FIGURE 8A

Table 5 provides a summary of the calculated factors of safety for the loading conditions outlined by the U.S. Army Corps of Engineers in EM 1110-2-1902, Table 3-1. Figures 8A through 8C and Figures 9A through 9C show the stability analyses outputs summarized in Table 5.
